Belzona Proven Cavitation Protection to Francis Turbine

ID: 1441

Customer Location: Hydroelectric plant, Slovakia
Application Date: 2019

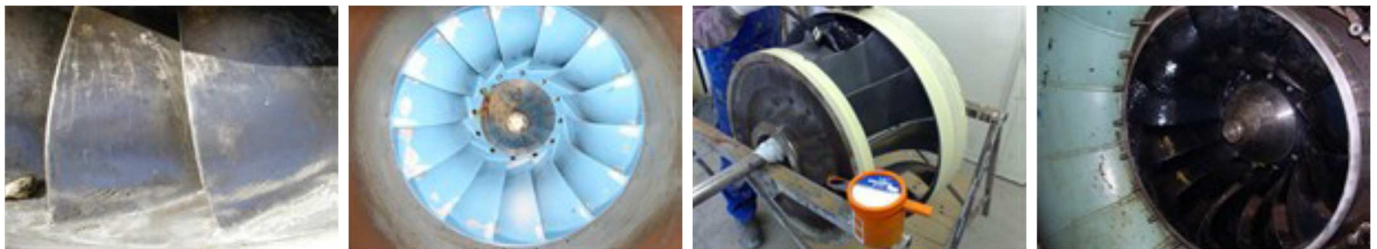
Photograph Descriptions

Cavitation had caused erosion of the metal and loss of turbine performance. Belzona® 1311 and Belzona® 1341 had been applied in 2004, but had suffered further cavitation, so system upgraded by applying more cavitation resistant Belzona® 2141.

1. Cavitation damage to turbine runner
2. Belzona® 1341 showing some cavitation damage
3. Belzona® 2141 being applied to the runner
4. After 24 months service Belzona® 2141, inspection shows no further cavitation damage

Inspection of the Belzona Ceramic coating in 2006 showed damage from cavitation, so specification was changed to Belzona® 2141. Further inspection after 2 years showed no damage on the turbine runner. In 2013 small areas of coating damage were repaired with further Belzona® 2141.
