Repairing Power Station Cooling Water Pumps with Belzona

ID: 7602

Customer Location: Power station, Slovakia
Application Date: 2014

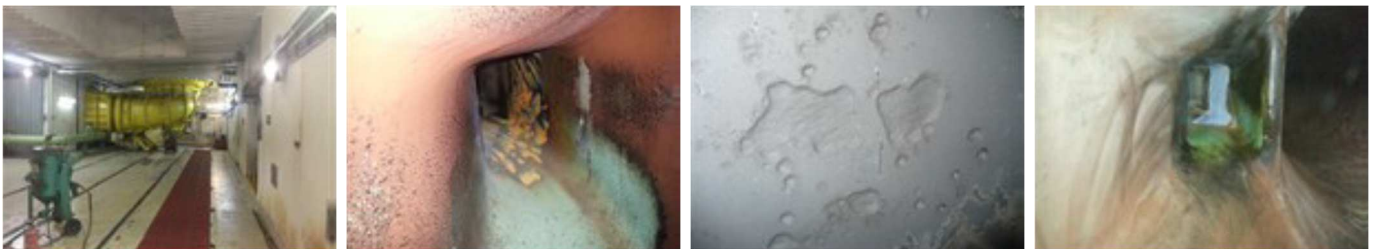
This pump had been in service for 35 years and was suffering erosion corrosion damage due to constant water flow.

1. TG pump
2. Damaged area
3. After blasting
4. After Belzona® 1311 and Belzona® 1341 application.

Application was carried out in accordance with Instructions for use.

Welding of these damaged parts would have been very difficult and taken a long time. Belzona solution is quick and with perfect quality. Belzona provides a corrosion resistant surface.
