Tube Sheet Engine Cooling Exchanger Protection with Belzona

Industry: Power
Application: HEX-Heat Exchangers
Substrate: Steel
Products: Belzona® 1111 (Super Metal),
Belzona® 4311 (Magma CR)

Customer Location: Nuclear electric power plant, Slovakia
Application Date: 2018, 2019, 2020

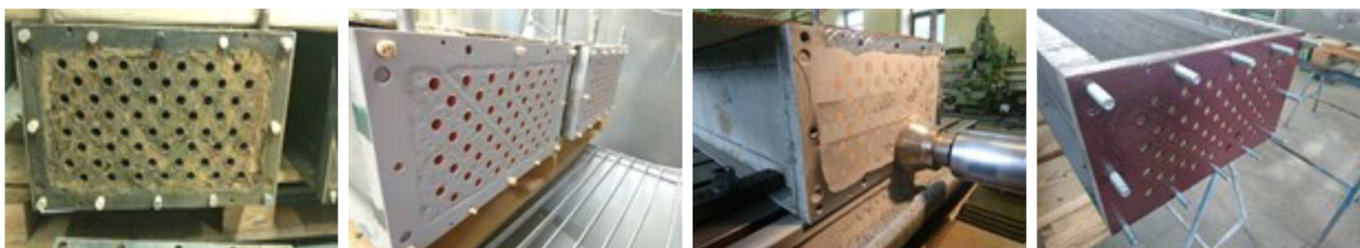
Photograph Descriptions

These strong acids even if they are diluted cause big corrosion.

1. Strong acids even if they are diluted cause big corrosion
2. The substrate was grit blasted and cleaned with Belzona® 9111
3. Tube sheets are levelled on the milling machine
4. The application was then protected by 2 coats of Belzona® 4311

Application was carried out in accordance with Instructions for use. The substrate was grit blasted and cleaned with Belzona® 9111. Then all the holes on tube sheets were plugged with corks. The corks were then cut at the tube level and Belzona® 1111 (Super Metal) was used to rebuild the substrate. Tube sheets are levelled on the milling machine after that. The application was then protected by 2 coats of Belzona® 4311 (Magma CR1). The corks are taken off with a drill. The tubes were then cleaned with compressed air.
