Belzona Repairs Manway Flange on Railway Tank

ID: 7574

Industry: *Chemical & Petrochemical* Customer Location: *Petrochemical company, Slovakia*
Application: *TCC-Tanks and Chemical Containment Areas* Application Date: *2011*
Substrate: *Steel*
Products: *Belzona® 1111 (Super Metal),
Belzona® 1391 (Ceramic HT)*

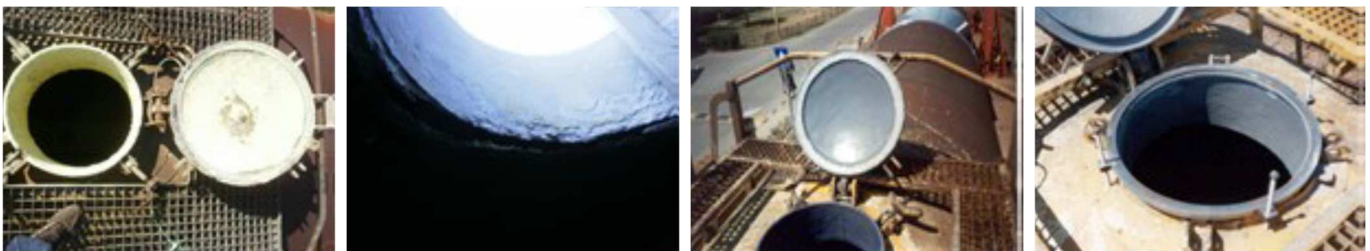
Photograph Descriptions

This tank was used to carry sulphuric acid however, the manway area was not suitably protected so suffered from corrosion damage.

1. Damaged manway
2. Following grit blasting
3. Completed application
4. Alternate view

Welding of a replacement flange was not an option for the customer. A rebuild and coat with Belzona solved the issue in a fraction of the time and cost, also preventing further damage from sulphuric acid.
