# Big Vacuum Oven Repair with Belzona® 1593

Industry: Chemical & Petrochemical  
Application: TCC-Tanks and Chemical Containment Areas  
Substrate: Steel  
Products: Belzona® 1593  
Belzona® 9111 (Cleaner Degreaser)

Customer Location: Slovakia  
Application Date: 2019

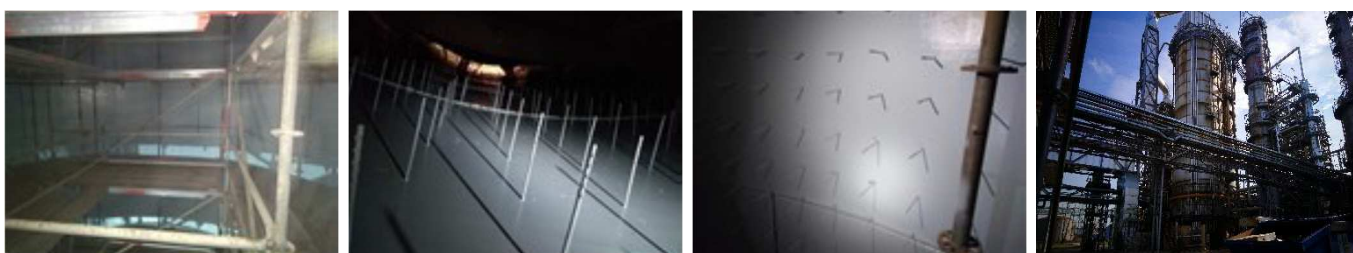
## Photograph Descriptions

The problem was: steel prickles inside which keep the oven insulation are degraded from acids throughout the life. Oven needed the protection against acids in high temperature.

1. It was necessary to erect up scaffolding
2. Steel prickles were coated too
3. 2nd coat of Belzona® 1593 applied
4. Oven ready to use

Application was carried out in accordance with Instructions for use. After blasting and cleaning, the oven was applied with Belzona® 1593 in 2 layers. The first coat of Belzona® 1593 was applied at 375 microns. After 12 hours the second coat was applied at 375 microns. Complete coating was finished in 2 days.
