Belzona® 5831 Protects Wet Surface of Steel Pipelines

ID: 8276

Customer Location: The largest pumped storage power plant in Slovakia.
Application Date: 2019, 2020

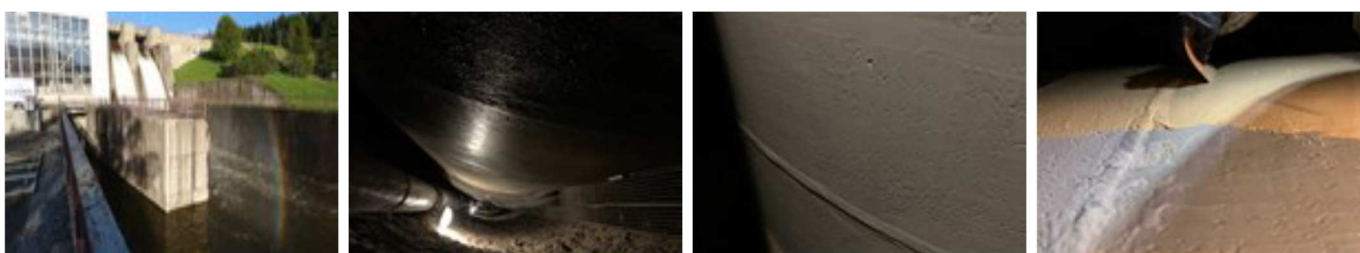
Photograph Descriptions

3 steel pipelines suffer from outside constant corrosion due to the moisty environment, so the customer needed to protect them. Space around of pipelines is not possible to make dry and it is not possible to use some conventional coats (also temperature of 5°C is a problem). It is necessary to use an environmental moisture-tolerant barrier coating.

1. Hydroelectric power plant
2. Wet surface of the steel pipeline in concrete tunnel
3. First layer done
4. Second layer of Belzona® 5831

Application was carried out in accordance with Instructions for use. The surface was abrasive blasted to prepare the area and Belzona® 5831 (ST-Barrier) was applied directly onto the prepared surface with a spatula in a two-coat system.
